HOME REPORT

10 BURNCROOKS AVENUE, BEARSDEN, GLASGOW, G61 4NL

Single Survey

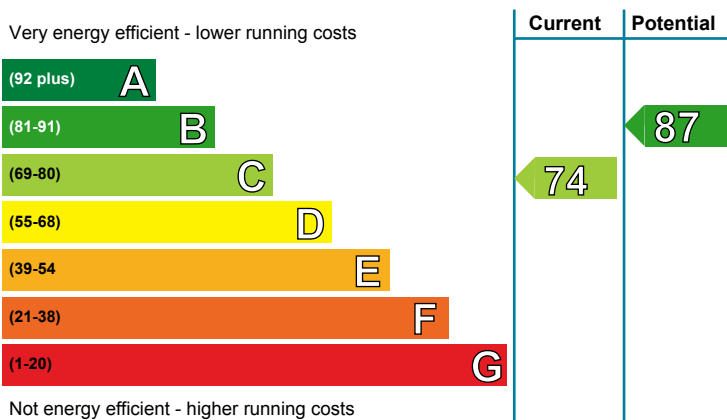
Energy Efficiency Rating

This graph shows the current efficiency of your home, taking into account both energy efficiency and fuel costs. The higher this rating, the lower your fuel bills are likely to be.

Your current rating is **band C (74)**. The average rating for EPCs in Scotland is **band D (61)**.

The potential rating shows the effect of undertaking all of the improvement measures listed within your recommendations report.

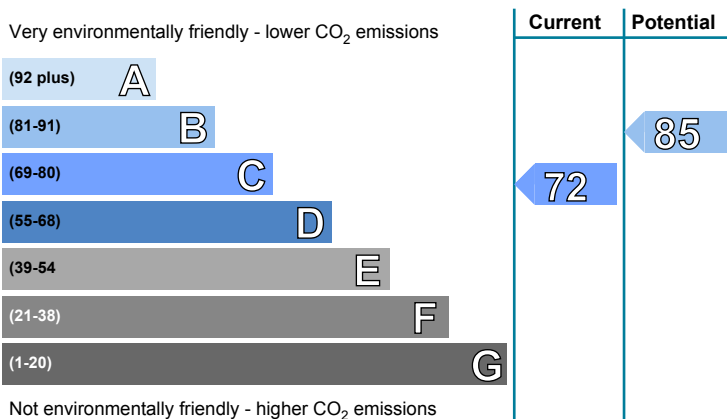
Environmental Impact (CO₂) Rating

This graph shows the effect of your home on the environment in terms of carbon dioxide (CO₂) emissions. The higher the rating, the less impact it has on the environment.

Your current rating is **band C (72)**. The average rating for EPCs in Scotland is **band D (59)**.

The potential rating shows the effect of undertaking all of the improvement measures listed within your recommendations report.
