HOME REPORT

16 ALLANDER ROAD, MILNGAVIE, GLASGOW, G62 8PN

Single Survey

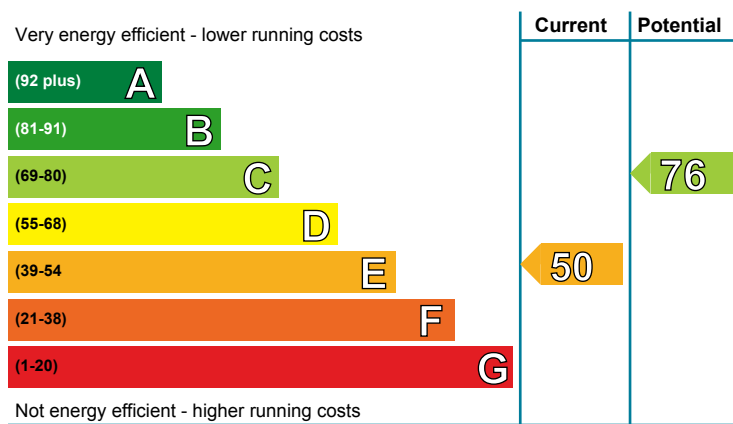
Energy Efficiency Rating

This graph shows the current efficiency of your home, taking into account both energy efficiency and fuel costs. The higher this rating, the lower your fuel bills are likely to be.

Your current rating is **band E (50)**. The average rating for EPCs in Scotland is **band D (61)**.

The potential rating shows the effect of undertaking all of the improvement measures listed within your recommendations report.

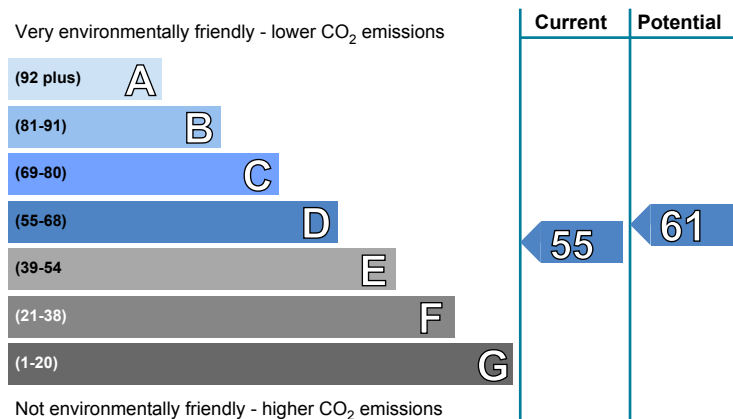
Environmental Impact (CO₂) Rating

This graph shows the effect of your home on the environment in terms of carbon dioxide (CO₂) emissions. The higher the rating, the less impact it has on the environment.

Your current rating is **band D (55)**. The average rating for EPCs in Scotland is **band D (59)**.

The potential rating shows the effect of undertaking all of the improvement measures listed within your recommendations report.
