YOUR ONESURVEY HOME REPORT

Flat 9a Glenburn Court 61a West King Street Helensburgh G84 8QX

SINGLE Survey

Single Survey

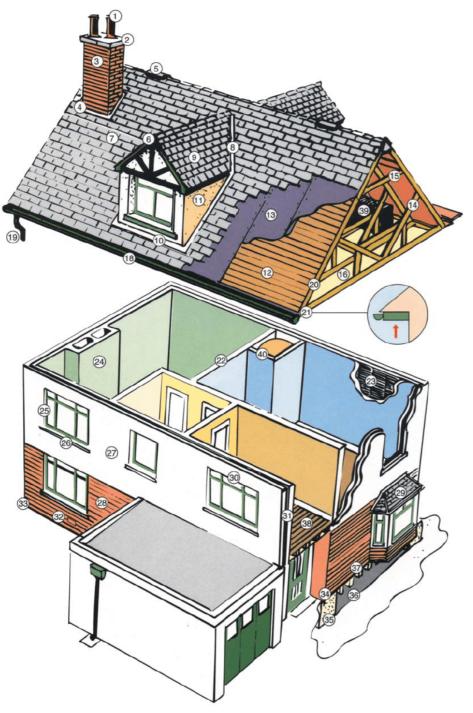
Sectional Diagram showing elements of a typical house

Coping stone (2) Chimney head (3) Flashing 4) **Ridge ventilation** (5) Ridge board (6) Slates / tiles ി Valley guttering (8) (9) Dormer projection (10) Dormer flashing (11) Dormer cheeks (12) Sarking (13) Roof felt (14) Trusses (15) Collar (16) Insulation (17) Parapet gutter (18) Eaves guttering (19) Rainwater downpipe Verge boards/skews 20 Soffit boards (21) Partiton wall (22) Lath / plaster (23) (24) Chimney breast Window pointing (25) Window sills (26) Rendering (27) (28) Brickwork / pointing (29) Bay window projection (30) Lintels (31) Cavity walls / wall ties (32) Subfloor ventilator (33) Damp proof course Base course 34) Foundations (35) Solum (36) Floor joists (37) Floorboards 38) Water tank (39) Hot water tank

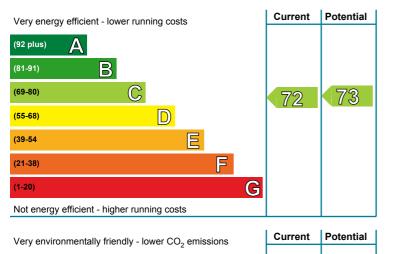
Energy Efficiency Rating

This graph shows the current efficiency of your home, taking into account both energy efficiency and fuel costs. The higher this rating, the lower your fuel bills are likely to be.
