HOME REPORT

Energy Performance Certificate (EPC)

FLAT 3/4, 53 MORRISON STREET, GLASGOW, G5 8LB

survey report on:

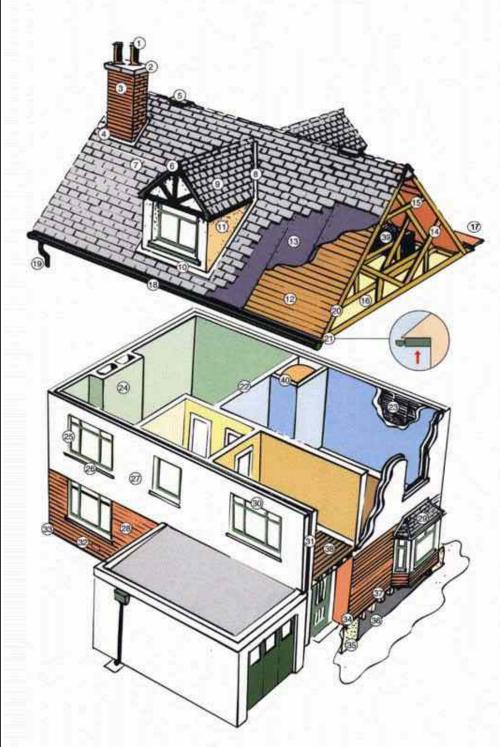
Sectional Diagram showing elements of a typical house

Reference may be made in this report to some or all of the above component parts of the property. This diagram may assist you in locating and understanding these items.

- 1 Chimney pots
- 2 Coping stone
- 3) Chimney head
- 4 Flashing
- 5) Ridge ventilation
- 6) Ridge board
- 7) Slates / tiles
- 8 Valley guttering
- 9) Dormer projection
- 10 Dormer flashing
- (11) Dormer cheeks
- 12) Sarking
- 13) Roof felt
- (14) Trusses
- (15) Collar
- (16) Insulation
- 17) Parapet gutter
- (18) Eaves guttering
- 19) Rainwater downpipe
- 0) Verge boards /skews
- 21) Soffit boards
- 22) Partition wall
- 23) Lath / plaster
- 24) Chimney breast
- (25) Window pointing
- 26) Window sills
- (27) Rendering
- (28) Brickwork / pointing
- (29) Bay window projection
- (30) Lintels
- (31) Cavity walls / wall ties
- 32) Subfloor ventilator
- 33) Damp proof course
- (34) Base course
- 35) Foundations
- 36) Solum
- 37) Floor joists
- 38) Floorboards
- 9) Water tank
- 10) Hot water tank
