HOME REPORT

106 MENZIES ROAD, GLASGOW, G21 3NG

SINGLE SURVEY

Property address	406 MENZIES DOAD
Troporty additions	106 MENZIES ROAD, GLASGOW, G21 3NG
Customer	Lucia Grant (Executor)
Customer address	106 Menzies Road, Glasgow, G21 3NG
Prepared by	DM Hall LLP
Date of inspection	4th April 2024
Prepared by	Glasgow, G21 3NG DM Hall LLP

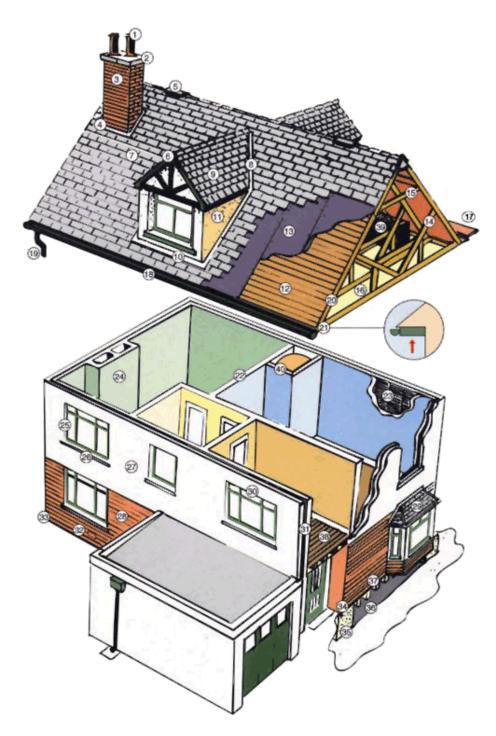
Sectional Diagram showing elements of a typical house

Reference may be made in this report to some or all of the above component parts of the property. This diagram may assist you in locating and understanding these items.

- 1) Chimney pots
- 2) Coping stone
- 3) Chimney head
- 4 Flashing
- 5) Ridge ventilation
- 6) Ridge board
- 7) Slates / tiles
- 8 Valley guttering
- 9 Dormer projection
- 10) Dormer flashing
- 11) Dormer cheeks
- (12) Sarking
- (13) Roof felt
- (14) Trusses
- 15) Collar
- (16) Insulation
- 17) Parapet gutter
- 18) Eaves guttering
- 19) Rainwater downpipe
- 20) Verge boards/skews
- 21) Soffit boards
- 22) Partition wall
- 23) Lath / plaster
- 24) Chimney breast
- (25) Window pointing
- 6) Window sills
- 27) Rendering
- (28) Brickwork / pointing
- 29) Bay window projection
- 30 Lintels
- (31) Cavity walls / wall ties
- 32) Subfloor ventilator
- (33) Damp proof course
- 34) Base course
- 35) Foundations
- 36) Solum
- 37) Floor joists
- 38) Floorboards
- 39) Water tank
- 40 Hot water tank
