HOME REPORT

50 MAXWELL DRIVE, GARROWHILL, GLASGOW, G69 6LS

Dwelling type: Semi-detached house
Date of assessment: 26 March 2024
Date of certificate: 26 March 2024
Total floor area: 70 m²
Primary Energy Indicator: 323 kWh/m²/year

Single Survey

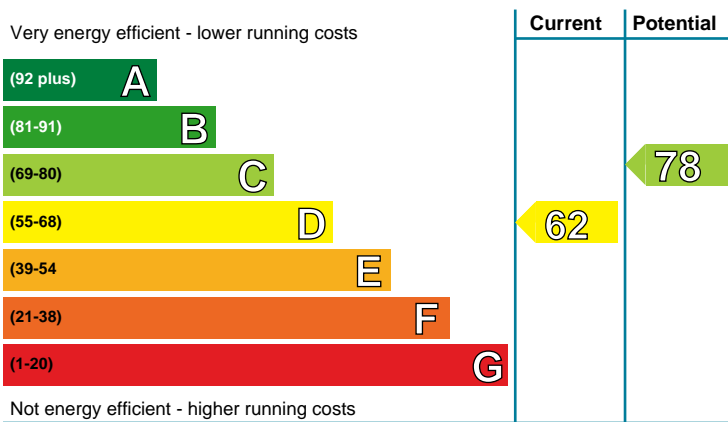
Energy Efficiency Rating

This graph shows the current efficiency of your home, taking into account both energy efficiency and fuel costs. The higher this rating, the lower your fuel bills are likely to be.

Your current rating is **band D (62)**. The average rating for EPCs in Scotland is **band D (61)**.

The potential rating shows the effect of undertaking all of the improvement measures listed within your recommendations report.

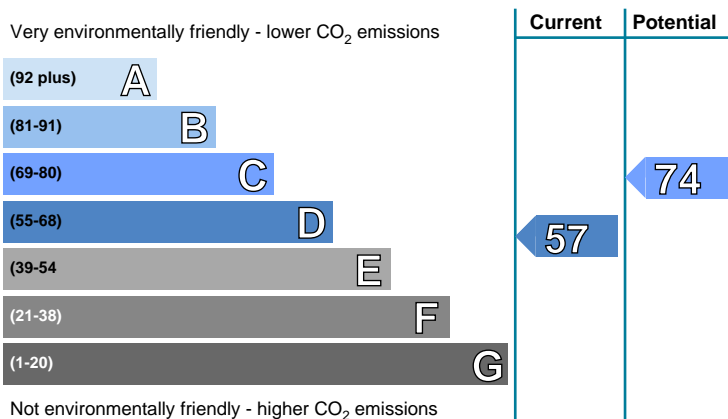
Environmental Impact (CO₂) Rating

This graph shows the effect of your home on the environment in terms of carbon dioxide (CO₂) emissions. The higher the rating, the less impact it has on the environment.

Your current rating is **band D (57)**. The average rating for EPCs in Scotland is **band D (59)**.

The potential rating shows the effect of undertaking all of the improvement measures listed within your recommendations report.

The average Scottish household produces about 6 tonnes of carbon dioxide every year. Based on this assessment, heating and lighting this home currently produces approximately 4.0 tonnes of carbon dioxide every year. Adopting recommendations in this report can reduce emissions and protect the environment. If you were to install all of these recommendations this could reduce emissions by 1.5 tonnes per year. You could reduce emissions even more by switching to renewable energy sources.
