HOME REPORT

Energy Performance Certificate (EPC)

9 EASTER LIVILANDS, STIRLING, FK7 0BQ

Dwelling type: Top-floor flat
Date of assessment: 05 April 2024
Date of certificate: 15 April 2024
Total floor area: 71 m²
Primary Energy Indicator: 548 kWh/m²/year

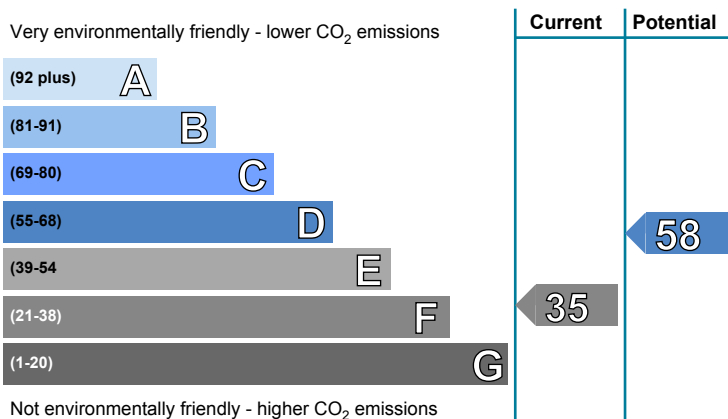
Environmental Impact (CO₂) Rating

This graph shows the effect of your home on the environment in terms of carbon dioxide (CO₂) emissions. The higher the rating, the less impact it has on the environment.

Your current rating is **band F (35)**. The average rating for EPCs in Scotland is **band D (59)**.

The potential rating shows the effect of undertaking all of the improvement measures listed within your recommendations report.

The average Scottish household produces about 6 tonnes of carbon dioxide every year. Based on this assessment, heating and lighting this home currently produces approximately 6.5 tonnes of carbon dioxide every year. Adopting recommendations in this report can reduce emissions and protect the environment. If you were to install all of these recommendations this could reduce emissions by 2.7 tonnes per year. You could reduce emissions even more by switching to renewable energy sources.
