# HOME REPORT

# Energy Performance Certificate (EPC)

FLAT 3/2 , 8 CRATHIE DRIVE, GLASGOW, G11 7XE

**Dwelling type:** Top-floor flat  
**Date of assessment:** 08 April 2024  
**Date of certificate:** 09 April 2024  
**Total floor area:** 42 m<sup>2</sup>  
**Primary Energy Indicator:** 348 kWh/m<sup>2</sup>/year

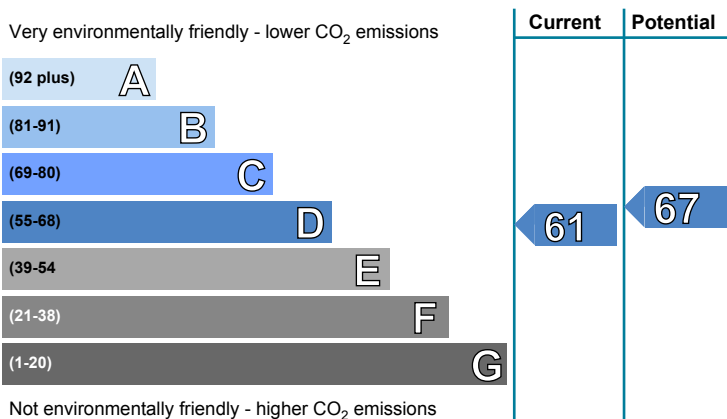
## Environmental Impact (CO<sub>2</sub>) Rating

This graph shows the effect of your home on the environment in terms of carbon dioxide (CO<sub>2</sub>) emissions. The higher the rating, the less impact it has on the environment.

Your current rating is **band D (61)**. The average rating for EPCs in Scotland is **band D (59)**.

The potential rating shows the effect of undertaking all of the improvement measures listed within your recommendations report.
