HOME REPORT

FLAT 0/1 , 5 BREVAL COURT, GLASGOW, G69 7BF

Dwelling type: Ground-floor flat
Date of assessment: 30 July 2024
Date of certificate: 31 July 2024
Total floor area: 52 m²
Primary Energy Indicator: 420 kWh/m²/year

Single Survey

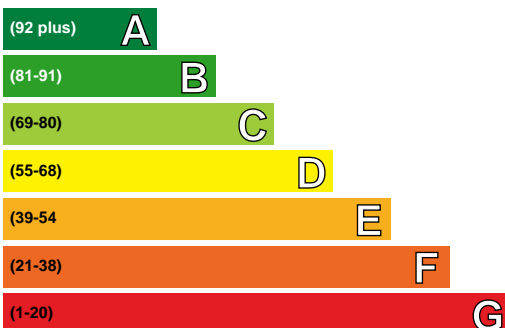
Energy Efficiency Rating

Current	Potential
65	77

This graph shows the current efficiency of your home, taking into account both energy efficiency and fuel costs. The higher this rating, the lower your fuel bills are likely to be.

Your current rating is **band D (65)**. The average rating for EPCs in Scotland is **band D (61)**.

The potential rating shows the effect of undertaking all of the improvement measures listed within your recommendations report.

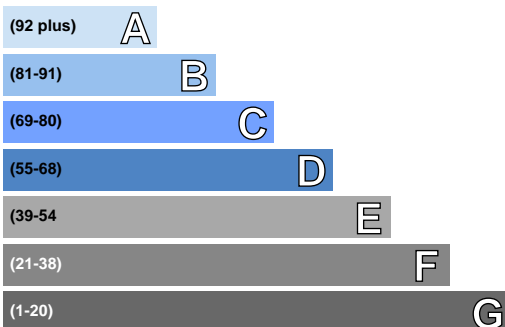
Environmental Impact (CO₂) Rating

Current	Potential
53	61

This graph shows the effect of your home on the environment in terms of carbon dioxide (CO₂) emissions. The higher the rating, the less impact it has on the environment.

The potential rating shows the effect of undertaking all of the improvement measures listed within your recommendations report.
